## APPENDIX B

## FIELD SITE DESCRIPTIONS

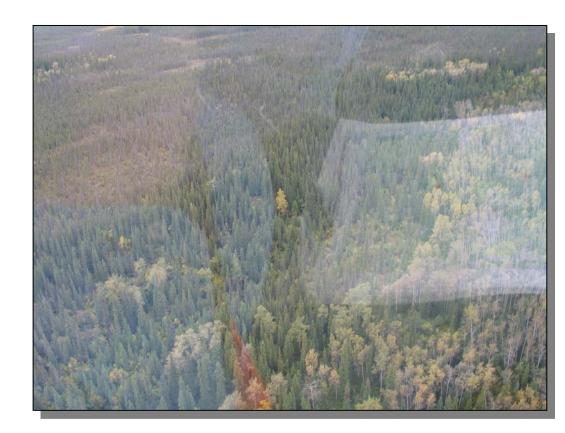
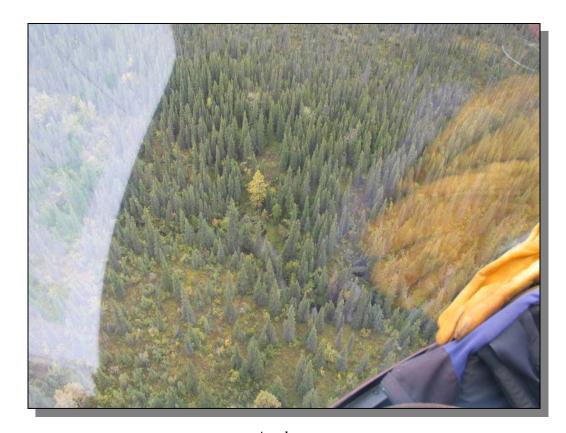
**EF Moose Creek** Pipeline MP 0.93 ADF&G Stream No. N/A **Site Visit: 9/2/05**

Crossing Description: The East Fork of Moose Creek is a low-gradient meandering stream with an estimated average stream width less than 10 feet. Its stream banks are generally bordered by heavy vegetation primarily consisting of stands of black spruce. Topographic relief along the proposed crossing is mild.

Soils Description: Interpreted terrain units of the crossing include lowland glaciofluvial meltwater deposits overlying and interspersed with glacial lacustrine deposits. These deposits generally consist of fine-grained material with scattered sand and gravel. Surface conditions indicated that permafrost may be encountered beneath this crossing.

Approximate location of pipeline crossing

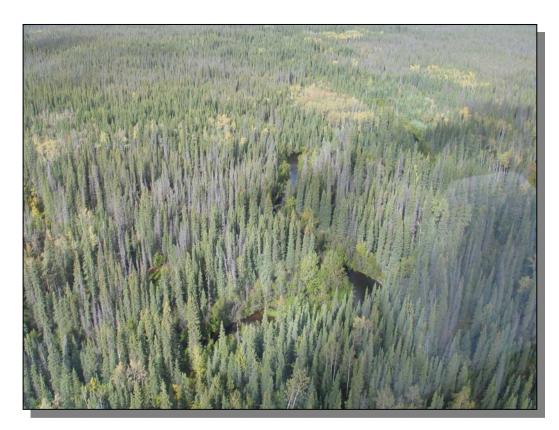
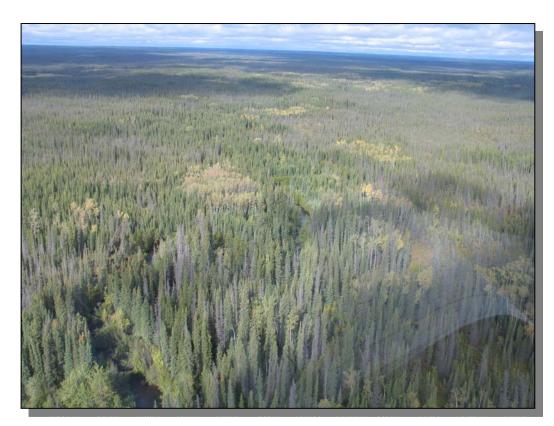
**Moose Creek** Pipeline MP 3.85 ADF&G Stream No. N/A **Site Visit: 9/2/05**

Crossing Description: Moose Creek is a low-gradient meandering stream with an estimated average stream width less than 20 feet. Its stream banks are generally bordered by heavy vegetation primarily consisting of stands of black spruce. Topographic relief along the proposed crossing is mild.

Soils Description: Soils from the left to right bank are interpreted as floodplain deposits consisting of fine-grained material with scattered sand and gravel. Surface conditions indicated that permafrost may be encountered beneath this crossing.

Approximate location of pipeline crossing, looking upstream.

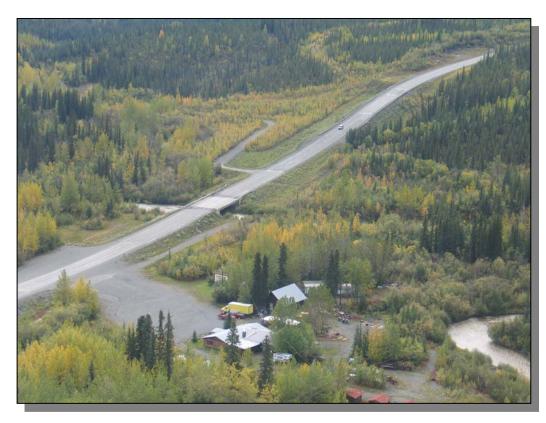
**Tolsona Creek** Pipeline MP 15.95 ADF&G Stream No. 212-20-10080-2431-3082 **Site Visit: 9/2/05**

Crossing Description: Tolsona Creek is a high-gradient straight stream with an estimated average stream width less than 40 feet. Its stream banks are generally bordered by previously cleared vegetation primarily consisting of low stands of shrub and brush. Topographic relief along the proposed crossing is mild. The pipeline is anticipated to cross the stream on the north side of the highway.

Soils Description: Terrain units on the left and right of the Tolsona Creek floodplain are interpreted as glacial lacustrine generally consisting of fine-grained material with scattered sand and gravel. Within the stream bed and active floodplain, DOT&PF bridge borings indicate a thin layer (<10 feet) of floodplain deposits generally consisting of gravel and sand, containing cobbles and boulders. Permafrost was not noted by DOT&PF. The floodplain material is underlain by glaciolacustrine silts containing occasional cobbles and boulders. Soils become significantly more dense at about 60 feet. Glacial till is interpreted to occur at a depth of approximately 60 feet.

Proposed pipeline crossing; creek flows from right to left. Pipeline is anticipated to be routed on the upstream side of the bridge.

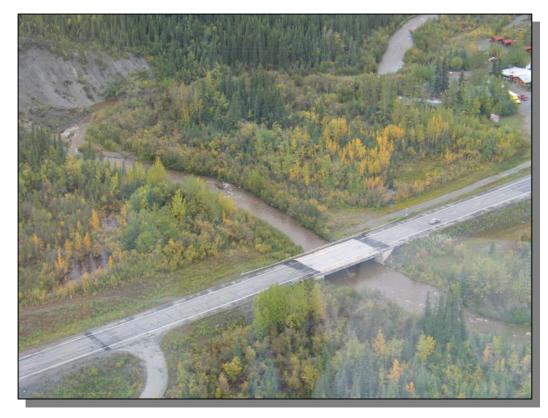
Creek is flowing from left to right.

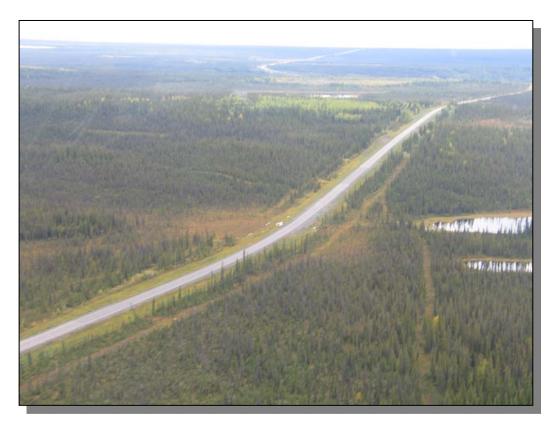
Duram Creek
Pipeline MP 18
ADF&G Stream No. 212-20-10080-2431-3075
Site Visit: 9/2/05

<u>Crossing Description</u>: Duram Creek appears to drain from Tolsona Lake to the Tazlina River toward the south. It appeared to be flowing through a bog-filled drainage swale. At the time of the site visit, Duram Creek was observed at a state of no flow. The drainage consists of a culvert running underneath the highway and appears to possibly drain into two lakes located on the south side of the highway. At periods of seasonal high water or flooding, total flow and stream gradient is anticipated to be low. Topographic relief along the crossing is minimal. The pipeline is anticipated to cross the stream on the north side of the highway.

<u>Soils Description</u>: Soils on both banks and underlying Duram Creek are interpreted as glacial lacustrine; generally consisting of fine-grained material with scattered sand and gravel. Permafrost and ice-rich soils can be anticipated at this crossing.

Creek flow is from left to right.

Duram Creek is believed to drain into lakes located in right center of photo.

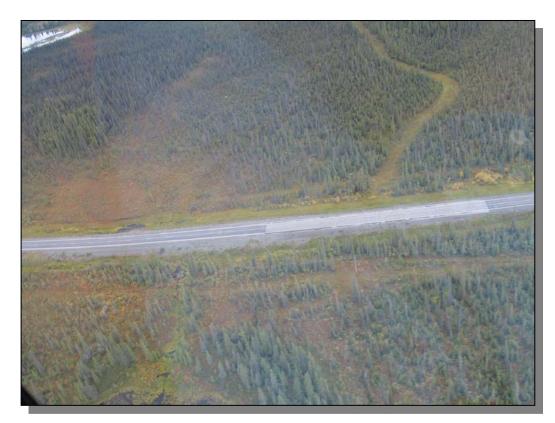
Looking upstream at Duram Creek crossing. Note repaired highway section.

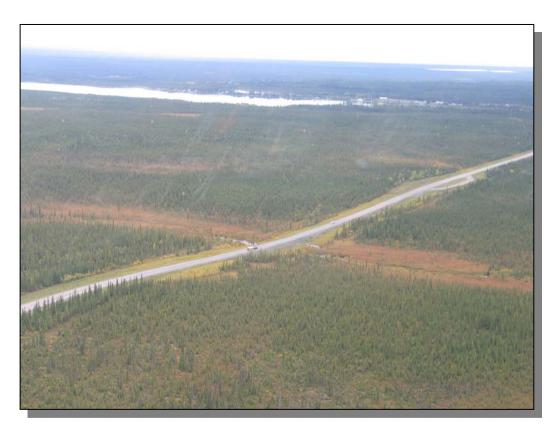
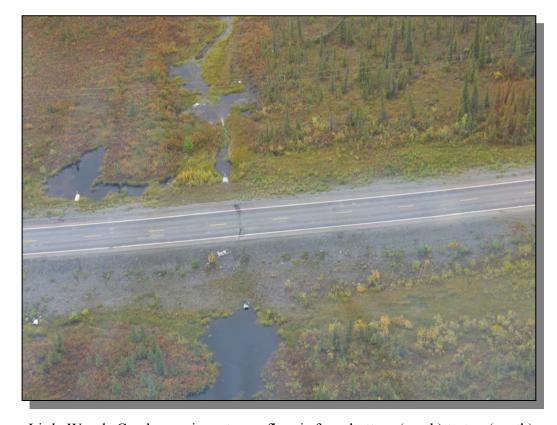
Little Woods Creek
Pipeline MP 20.09
ADF&G Stream No. N/A
Site Visit: 9/2/05

<u>Crossing Description</u>: Little Woods Creek is a low-gradient straight stream with an estimated maximum width of less than five feet within the vicinity of the proposed crossing. Its stream banks are generally free from any dense vegetation stands and the predominant vegetation type is interpreted as moist lowland tundra. The pipeline is anticipated to cross the stream on the north side of the highway.

<u>Soils Description</u>: Immediately underneath and on both sides of the stream bed, soils are interpreted as being organics overlying fine-grained floodplain deposits. Organics generally consist of decomposed and undecomposed organic material with some silt. The floodplain deposits generally consist of silt and clay with scattered sand and gravel. To the east and west and coinciding with the black spruce vegetation line, soils are interpreted to be lacustrine deposits overlying glacial till. The lacustrine deposits generally consist of sandy silt and silty sand with some clay and occasional pebbles while the underlying glacial till deposits generally consist of gravelly silty sand and gravelly sandy silt containing cobbles and boulders. Surface conditions indicated that permafrost may be encountered beneath this crossing.

Little Woods Creek crossing, stream flow is from left (north) to right (south).

Little Woods Creek crossing, stream flow is from bottom (north) to top (south).

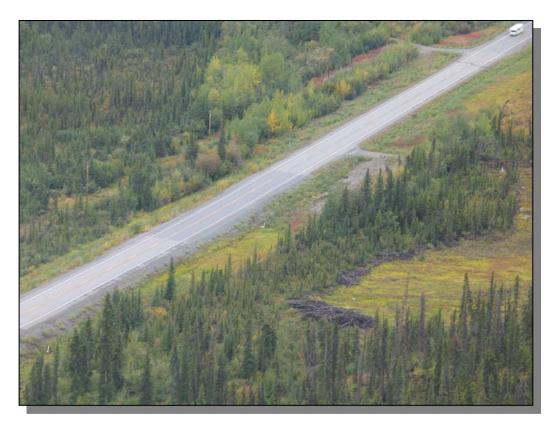
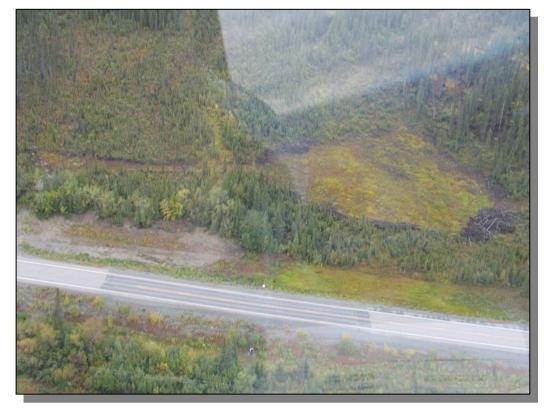
Atlasta Creek
Pipeline MP 23.9
ADF&G Stream No. 212-20-10080-2431-3122
Site Visit: 9/2/05

<u>Crossing Description</u>: At the time of the site visit, Atlasta Creek was observed to be in a period of no flow. Debris flows consisting of black spruce observed on the north side of the road were interpreted to have been deposited by surface water sheet flow. Therefore, Atlasta Creek is interpreted to have an extremely variable flow rate which is dependant on surface water runoff. The pipeline is anticipated to cross the stream on the south side of the highway.

<u>Soils Description</u>: Soils within the immediate vicinity of the proposed crossing are interpreted as being glacial till interspersed with some colluvium overlying glacial till. The colluvium generally consists of various mixtures of sand, silt, and gravel containing scattered cobbles and boulders which have been transported downslope from bedrock exposures north of the crossing. The glacial till generally consists of gravelly silty sand and gravelly sandy silt containing cobbles and boulders. Surface conditions indicated that permafrost may be encountered under this crossing.

Atlasta Creek crossing, stream flow is from right (north) to left (south).

Atlasta Creek crossing, stream flow is from top (north) to bottom (south).

Note repaired pavement section.

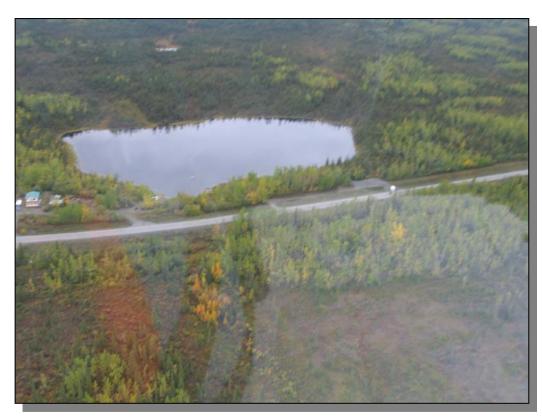
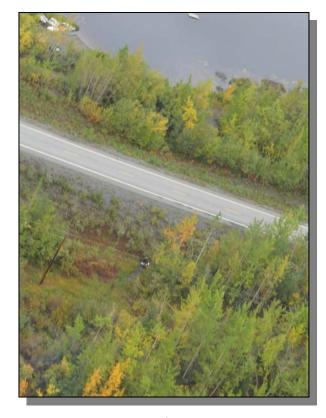
Tex Smith Lake Drainage Pipeline MP 26.76 ADF&G Stream No. N/A Site Visit: 9/2/05

<u>Crossing Description</u>: At the time of our site visit Tex Smith Lake drainage was observed at a state of no flow. The drainage consists of a culvert running underneath the highway and appears to periodically drain the lake located on the north side of the highway. At periods of seasonal high water or flooding, total flow and stream gradient is anticipated to be low. Topographic relief along the crossing is minimal. The pipeline is anticipated to cross the stream on the south side of the highway.

<u>Soils Description</u>: Soils within the immediate vicinity of the proposed crossing are interpreted as being glacial till interspersed with some colluvium overlying glacial till. The colluvium generally consists of various mixtures of sand, silt, and gravel containing scattered cobbles and boulders which have been transported downslope from bedrock exposures north of the crossing. The glacial till generally consists of gravelly silty sand and gravelly sandy silt containing cobbles and boulders. Surface conditions indicate that permafrost may be encountered at this crossing.

Overview of Tex Smith Lake drainage crossing. Drainage flow is from top (north) to bottom (south).

As above. Note drainage culvert in center of photo.

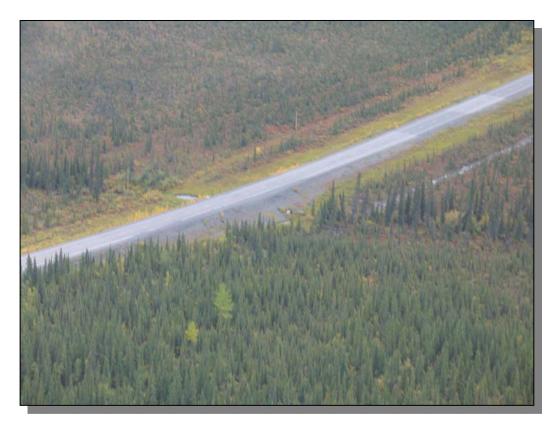
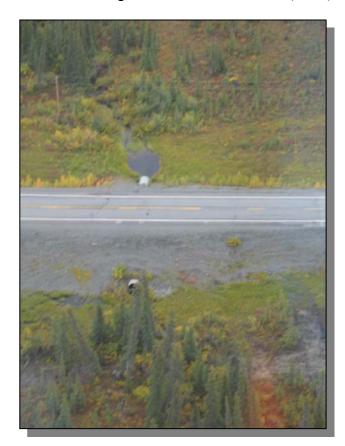
Woods Creek
Pipeline MP 34.51
ADF&G Stream No. 212-20-10080-2431-3122-4010
Site Visit: 9/2/05

<u>Crossing Description</u>: Woods Creek is a low-gradient straight stream with an estimated maximum width of less than five feet within the vicinity of the proposed crossing. Its stream banks are generally free from any dense vegetation stands and the predominant vegetation type is interpreted as moist lowland tundra. The pipeline is anticipated to cross the stream on the north side of the highway.

<u>Soils Description</u>: Immediately underneath and on both sides of the stream bed, soils are interpreted as being organics overlying floodplain deposits. Organics generally consist of decomposed and undecomposed organic material with some silt while floodplain deposits generally consist of gravel and sand containing cobbles and boulders. Surface conditions indicated that permafrost may be encountered at this crossing.

Proposed Woods Creek crossing, stream flow is from left (north) to right (south).

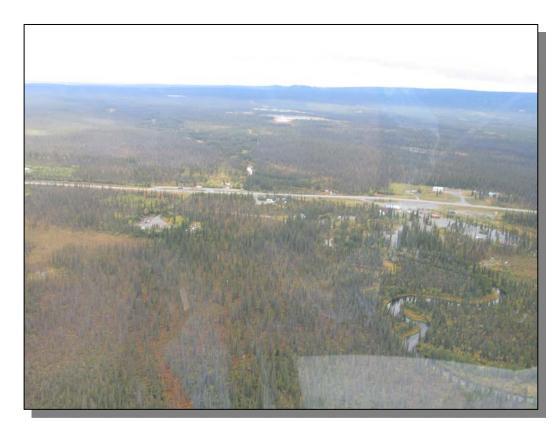
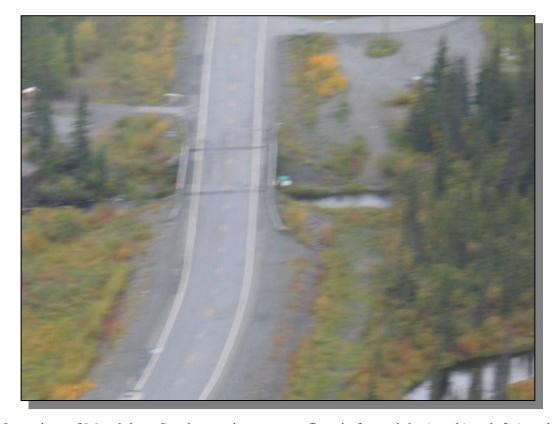
Mendeltna Creek Pipeline MP 35.8 ADF&G Stream No. 212-20-10080-2431-3142 Site Visit: 9/2/05

<u>Crossing Description</u>: Mendeltna Creek is a low-gradient meandering stream with an estimated average stream width less than 40 feet. Its stream banks are generally bordered by previously cleared vegetation primarily consisting of low stands of shrub, brush, and black spruce. Topographic relief along the proposed crossing is mild. The pipeline is anticipated to cross the stream on the north side of the highway.

<u>Soils Description</u>: Soils from the left to right bank are interpreted as floodplain deposits consisting of fine-grained material with scattered sand and gravel. Immediately to the west of the right bank floodplain, soils are interpreted as being glacial lacustrine deposits also consisting of fine-grained material with scattered sand and gravel. Surface conditions indicate that permafrost may be present in the stream banks but may be absent under the channel.

Overview of Mendeltna Creek crossing, stream flow is from top (north) to bottom (south).

Overview of Mendeltna Creek crossing, stream flow is from right (north) to left (south).

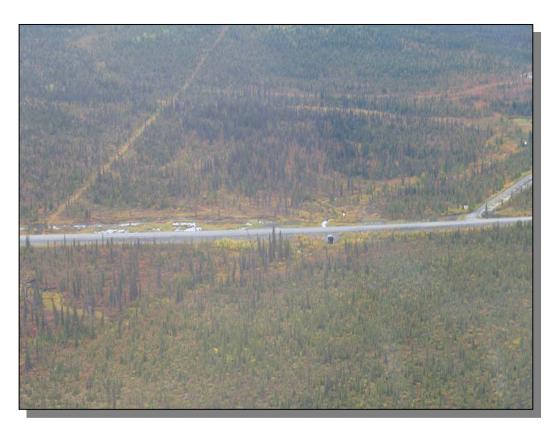
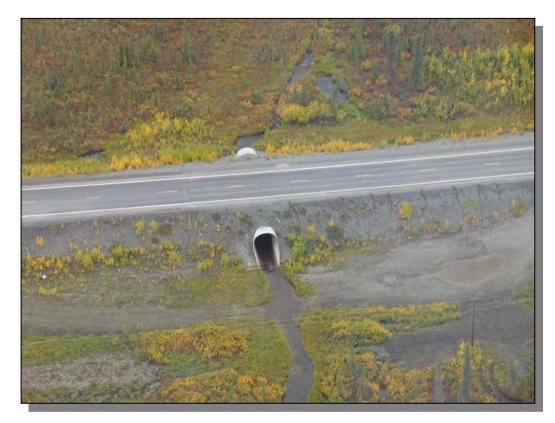
Cache Creek
Pipeline MP 41.22
ADF&G Stream No. N/A
Site Visit: 9/2/05

<u>Crossing Description</u>: At the time of our site visit Cache Creek was observed in a state of low flow. The drainage consists of a culvert running beneath the highway and drains Snowshoe Lake to the north. At periods of seasonal high water or flooding, total flow and stream gradient is anticipated to increase. Topographic relief along the crossing is minimal. The pipeline is anticipated to cross the stream on the north side of the highway.

<u>Soils Description</u>: Soils on the right bank of Cache Creek are anticipated to be colluvium overlying glacial lacustrine deposits. Soils on the left bank are interpreted as glacial lacustrine deposits. Colluvium deposits generally consist of various mixtures of sand, silt and gravel with scattered cobbles and boulders. Glacial lacustrine deposits generally consist of fine-grained material with scattered sand and gravels. Surface conditions indicate that permafrost may be encountered at this crossing.

Overview of Cache Creek crossing, stream flow is from top (north) to bottom (south).

Overview of Cache Creek crossing, stream flow is from bottom (north) to top (south).
